Technical Report No. 68.140.17.455.01 Dated 2017-06-08

Client:	Name: MSD LIGHTING CO., LIMITED Address: 6/F, Lixinda Industrial Park, No. 14 of Zhengcheng Road 1, Fuyong, Bao'an, PEOPLE'S REPUBLIC OF CHINA Contact person: Tony Tan					
Manufacturing place:	Manufacturer's name: Same as client Address: Same as client Factory's name: Same as client Address: Same as client					
Test subject:	Product: LED Linear Light Type: TPSL0621-WX; TPSL0621-WY; TPSL1241-WX; TPSL1241-WY; TPSL1551-WX; TPSL1551-WY; TPSL1261-WX; TPSL1261-WY; TPSL1581-WX; TPSL1581-WY Trade mark: N/A					
Test specification:	IK10 test according to EN 62262:2002.					
Purpose of examination:	 inspection according to specified requirements to realize the conformity with the Produktsicherheitsgesetz –ProdSG, version Nov 08, 2011 inspection according to specified requirements to realize the observance of the protection aims of the following EC directives: LVD directive 2014/35/EU EMC directive 2014/30/EU

3.1 IK10 code test [according to EN 62262:2002]

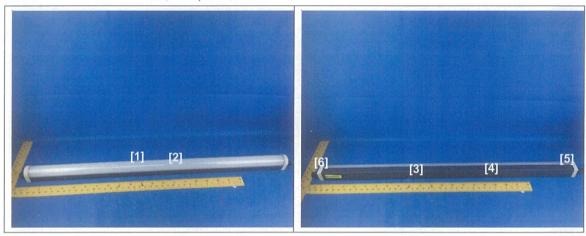
Test part	Impact No.	Impact energy (J)	Test evaluation
Test model: TPSL158	31-WY		
Plastic cover [1]	3	20	Admissible damage
Plastic cover [2]	2	20	Admissible damage
Metal enclosure [3]	3	20	Admissible damage
Metal enclosure [4]	2	20	Admissible damage
Metal end cover [5]	3	20	Admissible damage
Metal end cover [6]	2	20	Admissible damage

Test model: TPSL1581-WY, test points as below:

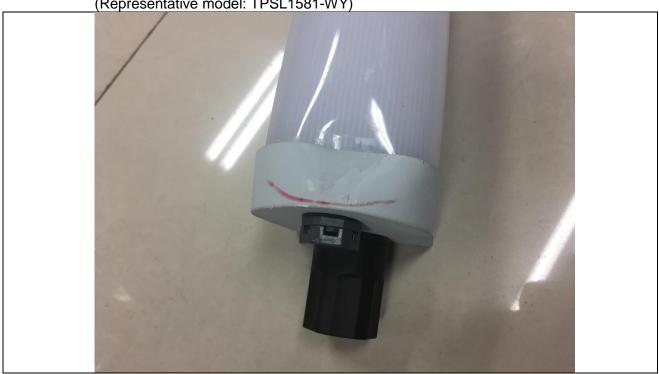
Details of: Metal end cover enclosure view after impacting test (Representative model: TPSL1581-WY)
